Courtney S. Glazer

1 February 1998

### **KAL Flight #801: Lessons on the Modification and Adaptation of the MSAW**

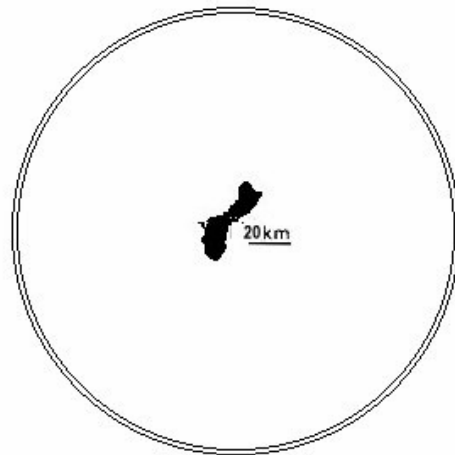
**Fig. 2: Guam's MSAW inhibit area**

this software patch that rendered Guam's

MSAW system useless (4). The adaptation of

the system to the location specific data after the

modification left the MSAW working within a ring 1

nautical mile wide at a distance of 54 nautical miles from the radar antenna. The MSAW

system was inhibited from processing within 54 nautical miles of the airport (3). As a

result, the tower at Guam never received either visual or aural warnings from the MSAW

system. In the case of KAL 801, the terrain maps were accurate, but the inhibit zone was

drastically wrong. Ultimately, the MSAW at Guam failed "due to a bug introduced into
